TECHNICAL REPORT ARCCB-TR-02016

CHARACTERIZATION OF EXPLOSIVELY BONDED AND FIRED TANTALUM LINERS APPLIED TO 25-MM GUN TUBES

NOVEMBER 2002

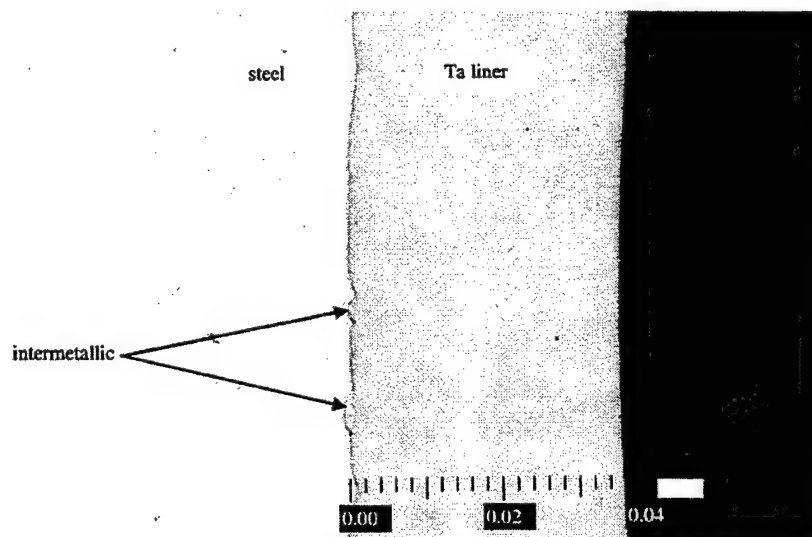
Figure 13. Metallurgical features of Tube A at 50X.

Metallographic examination of the unfired specimen revealed a fully dense, defect-free liner material (Figure 13). Along much of the steel/tantalum interface there appeared a hard, brittle intermetallic at all locations. The waveform of the interface is illustrated in Figure 14.

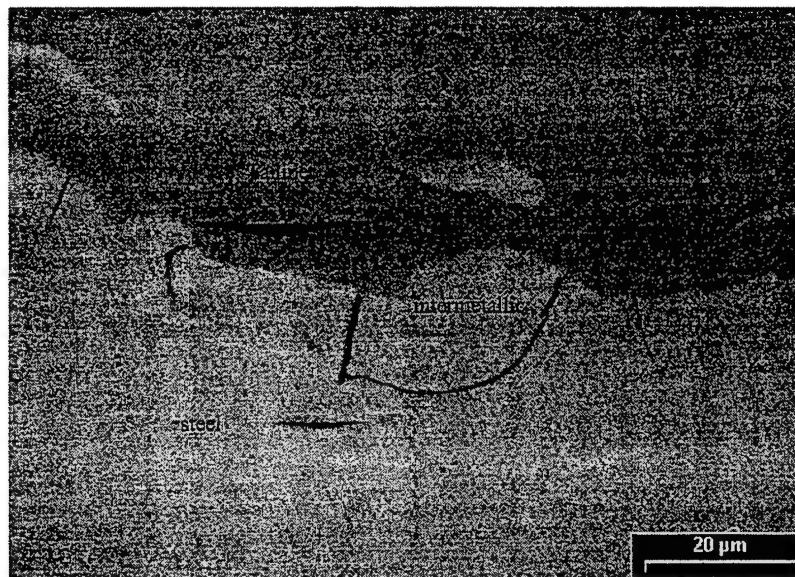
Figure 15. Tube B hardness variations of steel, liner, and intermetallic.

The liner of Tube B exhibited the same bulk features as Tube A. The liner was dense and defect-free and along much of the interface, a brittle and cracked intermetallic was present. The microhardness of the intermetallic in this tube was also $\sim\text{HK}_{50}$ 900. An image illustrating the comparative hardness values of the steel, intermetallic, and tantalum liner is given in Figure 15. Besides minor plastic deformation, the steel microstructure appeared relatively unaffected by the explosive bonding process. The one location examined in which the microstructure of the steel was noticeably altered occurred at the 8-inch location (Figure 16b). Although the microstructure is altered, there is no significant hardening or softening of the steel, so the ramifications of this insofar as fatigue life is concerned are unknown.

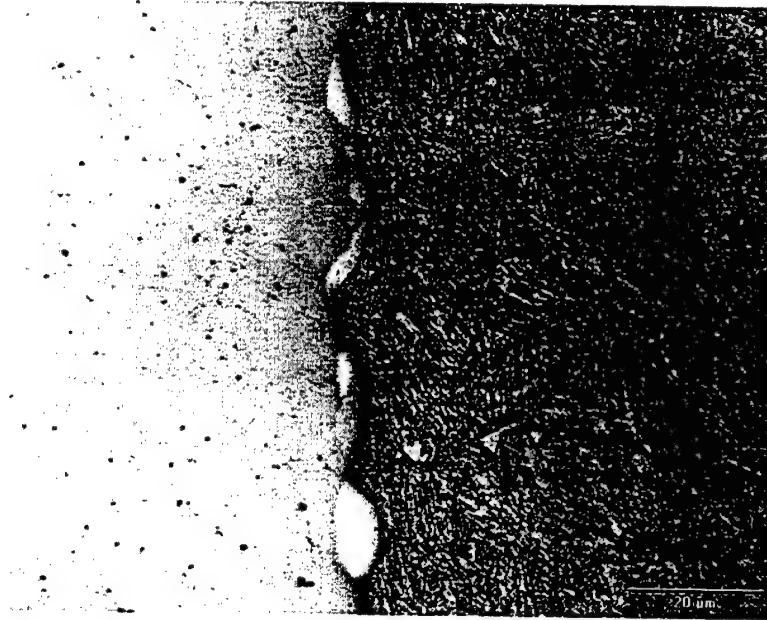
Figure 26: Explosively bonded tantalum/steel interface of Sample A at magnification 2000X.

Also observed was the formation of an intermetallic phase found at random locations throughout the irregular explosively bonded tantalum/steel interface, as shown in Figure 26. As no heat-affected zone is seen adjacent to these regions, this intermetallic phase was produced without high heating. These results are consistent with the cold welding process attributed to explosive bonding.

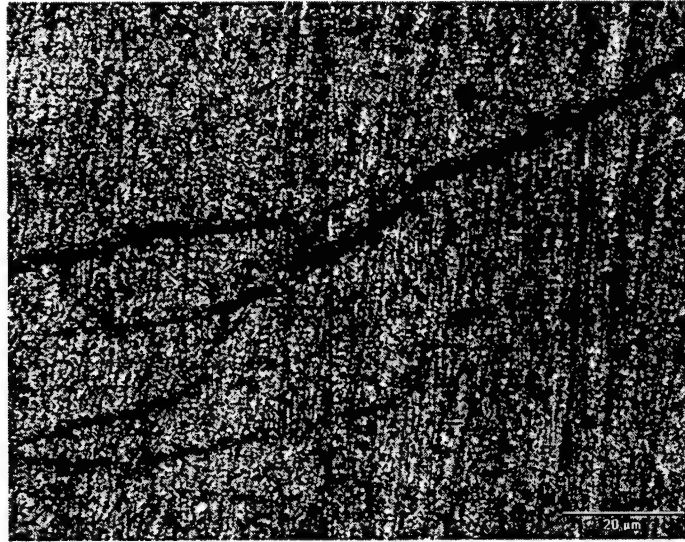
Figure 27. Laser pulsed region of unfired explosively bonded tantalum coating at magnification 2000X.

Staining throughout the pulsed region indicates that an oxide layer formed during heating. It was observed that there is a tendency for rapid oxidation of the explosively bonded tantalum during pulsing in air at ambient conditions. The surface cracks shown here are representative of those found throughout spot 1, with widths ranging from approximately 0.5 to 3.0 μm .

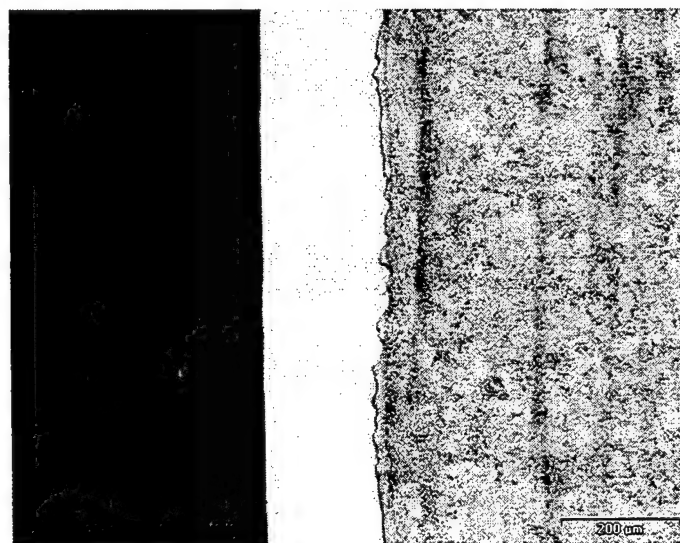
Figure 28. Laser pulsed spot 1 at magnification 200X.

Figure 28 shows the cross-section of spot 1 taken at a magnification 200X. This image illustrates cracking of the brittle intermetallic phase, along with the formation of a small heat-affected zone in the steel adjacent to the interface. Coating thickness is approximately 210 μm within the pulsed region.

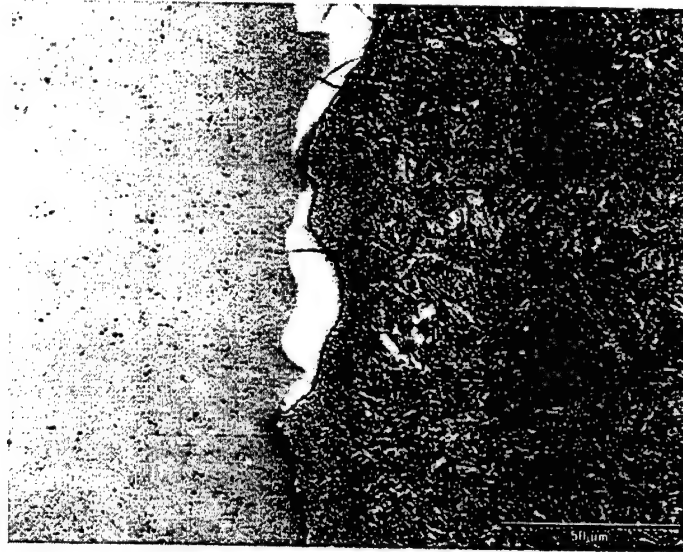
Figure 29. Effects of laser pulsing spot 1 at magnification 1200X.

While fine cracking of the intermetallic phase was seen throughout some locations along the interface, larger cracks were found in the intermetallic phase within the laser pulsed regions. Figure 29 shows the interface of spot 1 at increased magnification.

Here the heat-affected zone is seen to extend approximately 8 to 15 μm into the steel substrate. It is nonuniform, and appears along the waveform where the steel rises higher into the coating. Figure 30 shows a 2- to 3- μm thick oxide layer that has formed on the tantalum surface. Within the cross-sections of the laser-heated spots, no surface cracks have progressed through the oxide layer, suggesting that the explosively bonded tantalum is resistant to crack propagation from thermal shock.

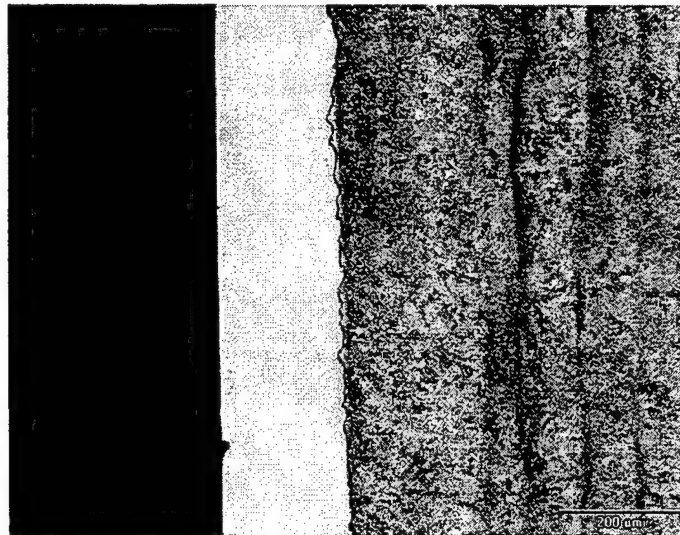
Figure 32. Laser pulsed spot 2 at magnification 200X.

Figure 32 also illustrates once again, the highly irregular interface with small regions of intermetallic phase present. A heat-affected zone is also seen in the steel adjacent to the interface. Coating thickness is approximately 210 μm within the pulsed region. Figure 33 shows this interface at increased magnification.

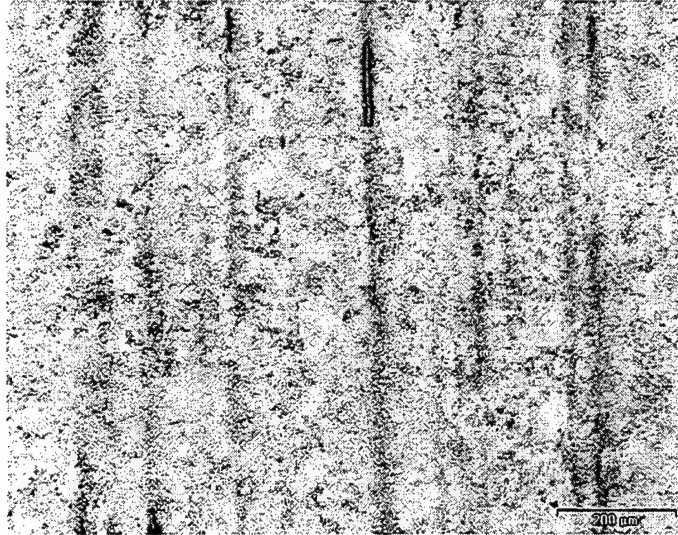
Figure 35. Substrate steel of fired explosively bonded tantalum-coated gun tube at magnification 200X. This cross-section is perpendicular to the bore and parallel to the tube axis.

Similar to the unfired specimen, etching revealed banding parallel to the tube axis and inclusions throughout the steel substrate of Sample B, as shown in the cross-section of Figure 35.

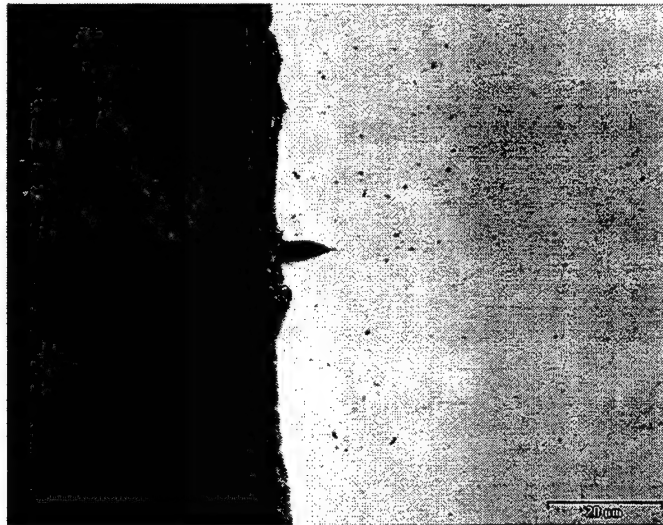
Figure 39. Surface oxide layer from laser pulsing spot 1 at magnification 2000X.

Figure 39 shows a 2- to 3- μm thick oxide layer that has formed at the tantalum surface. Here a surface crack is shown that has progressed through the oxide layer into the explosively bonded tantalum, and has propagated about 9 μm into the coating.

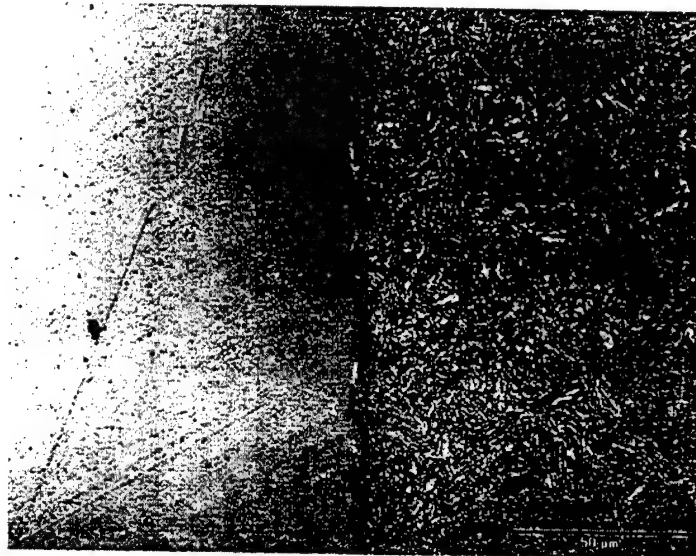
Figure 42: Effects of laser pulsing spot 1 at magnification 1200X.

Figure 42 shows this interface at increased magnification. Here the small heat-affected zone is seen to extend approximately 3 to 4 μm into the steel substrate.

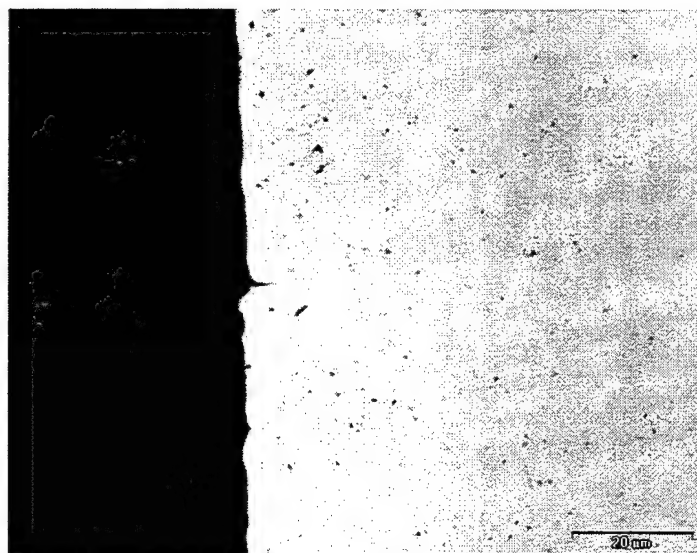
Figure 43. Surface oxide layer from laser pulsing spot 2 at magnification 2000X.

Figure 43 shows a 2- to 3- μm thick oxide layer that has formed at the tantalum surface. Within this region, one surface crack has progressed through the oxide layer.
